# Evolution of Wairau

## Flooding and Water Quality

Nick Vigar, Head of Network Planning, Healthy Waters

December 2024

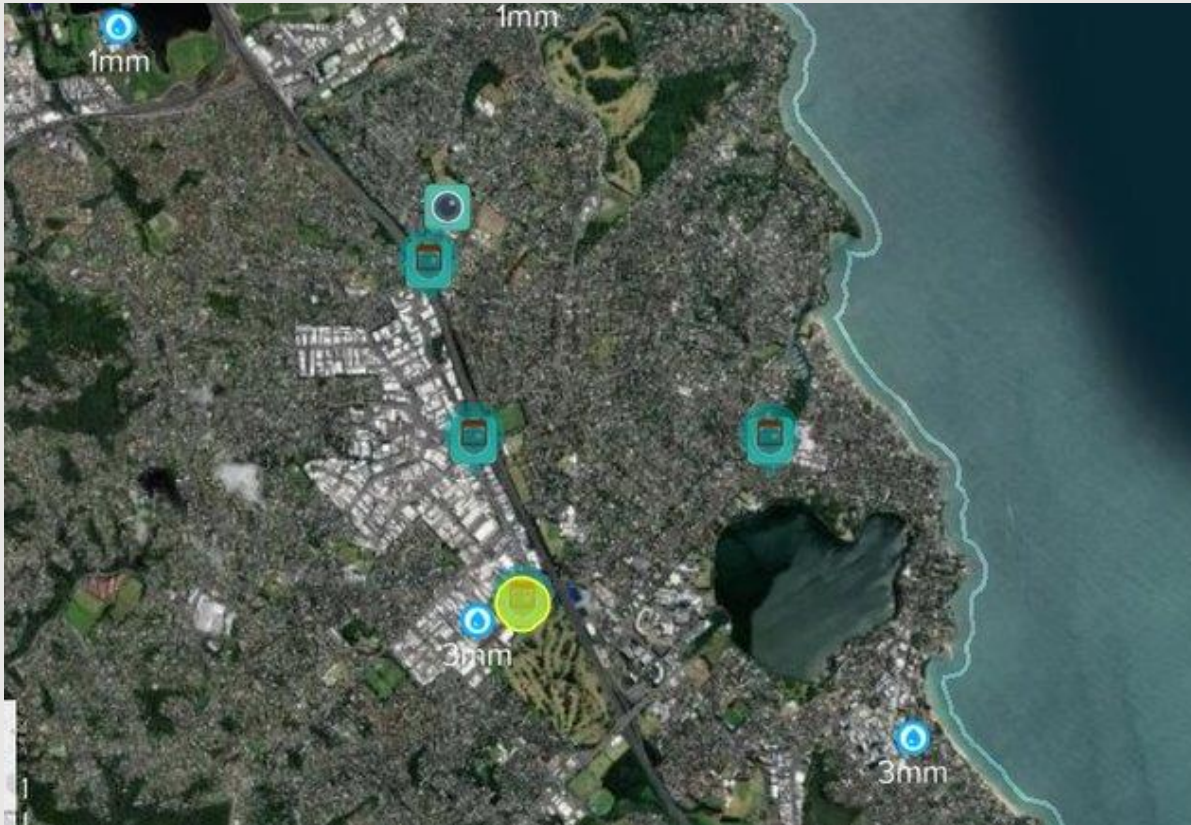
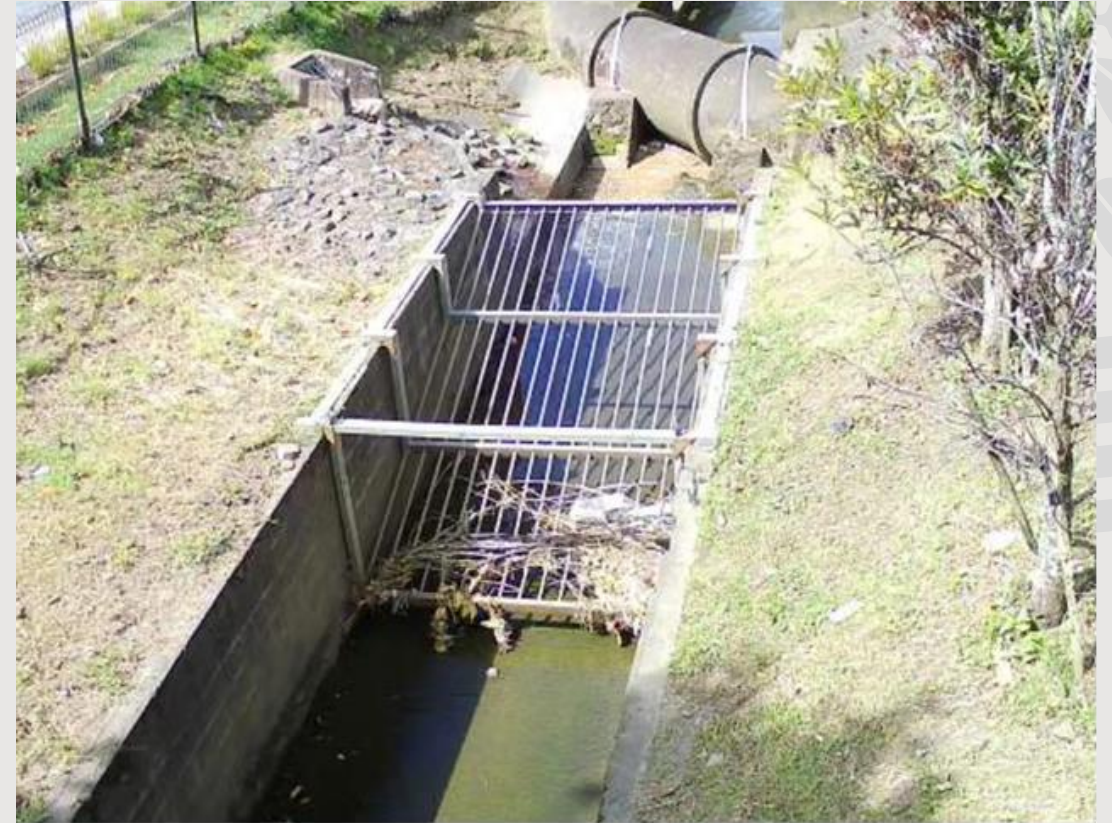
- More monitoring cameras installed
- Increased catch-pit cleaning
- New water quality treatment device installed
- Plans to dredge watercourse at Bryan Byrnes Reserve, desilting of Link Drive pond
- Other increased maintenance expected from early 2025

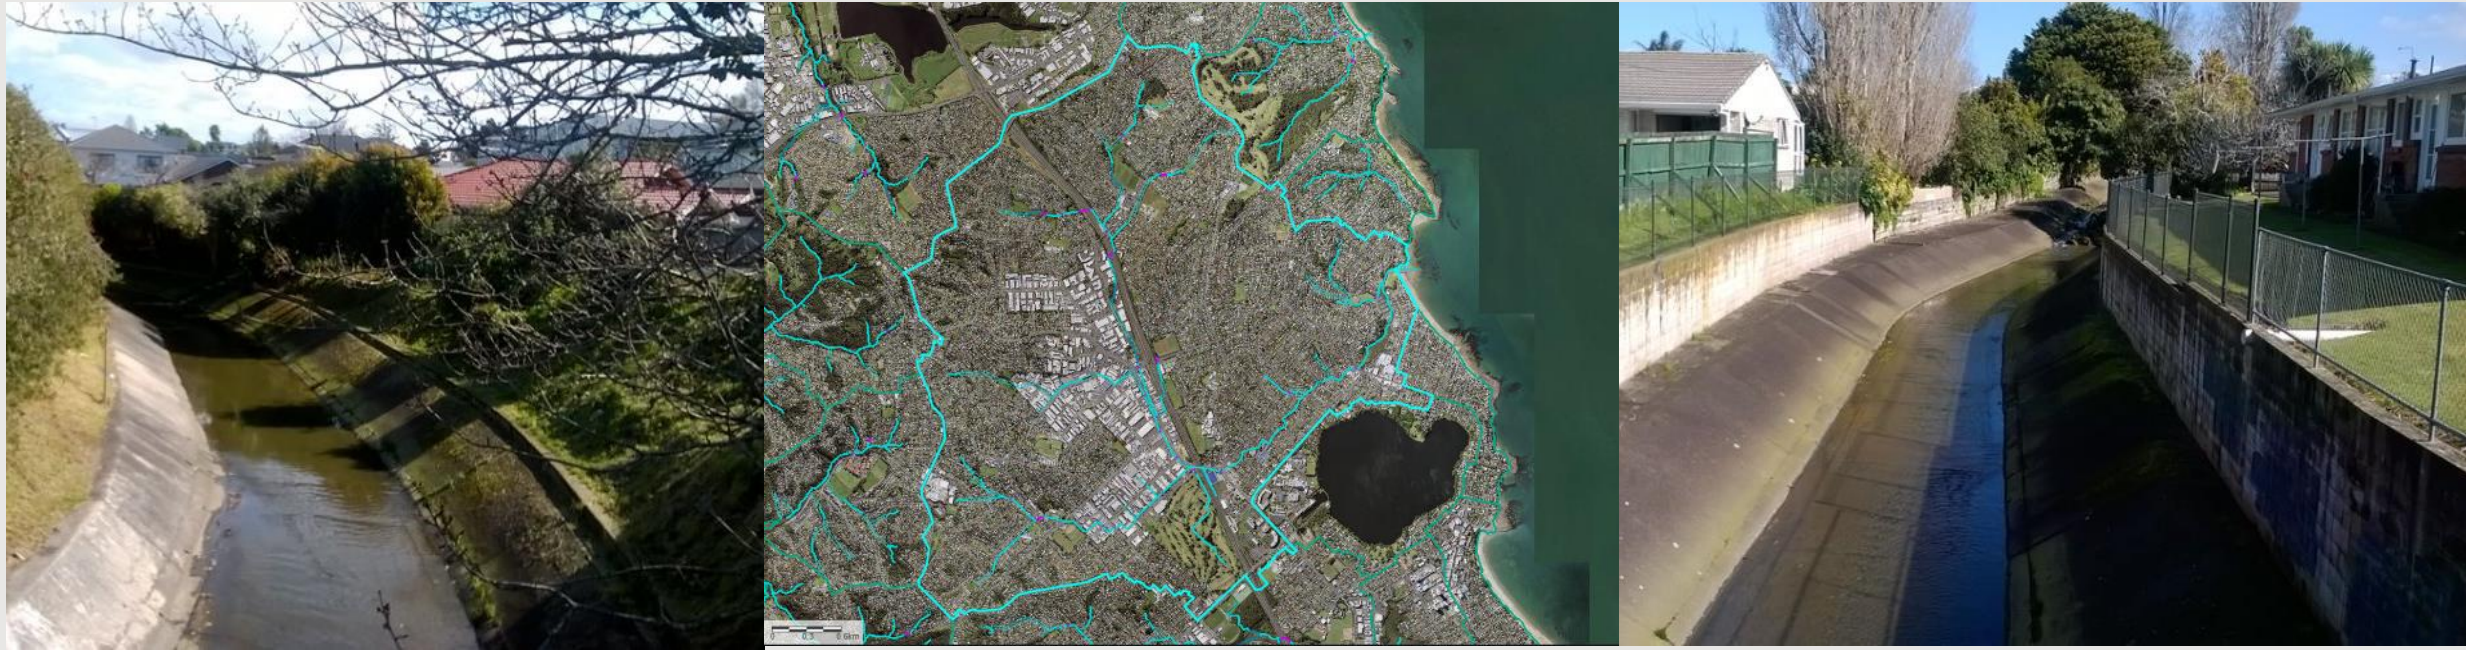
- ↑ **zinc** from vehicles (tyre wear) and roofs (galvanized steel)
- ↑ **copper** from vehicles (brake pads)
- ↑ other metals: lead (historic), cadmium (trace)
- ↑ hydrocarbons, PAHs (vehicles)

TSS (Fine sediment)	Copper	Zinc
1,041 ton/yr	29kg/yr	189 kg/yr

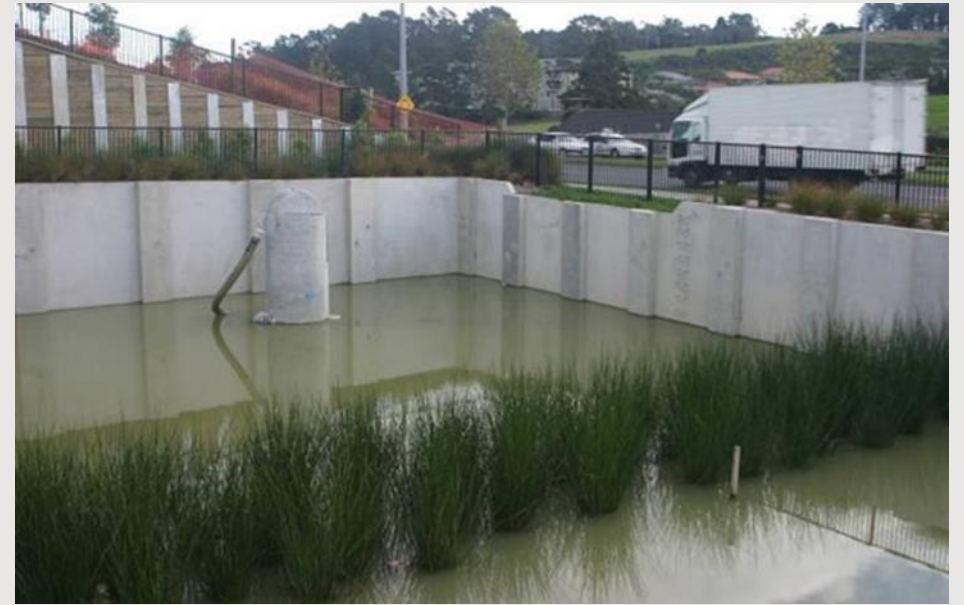
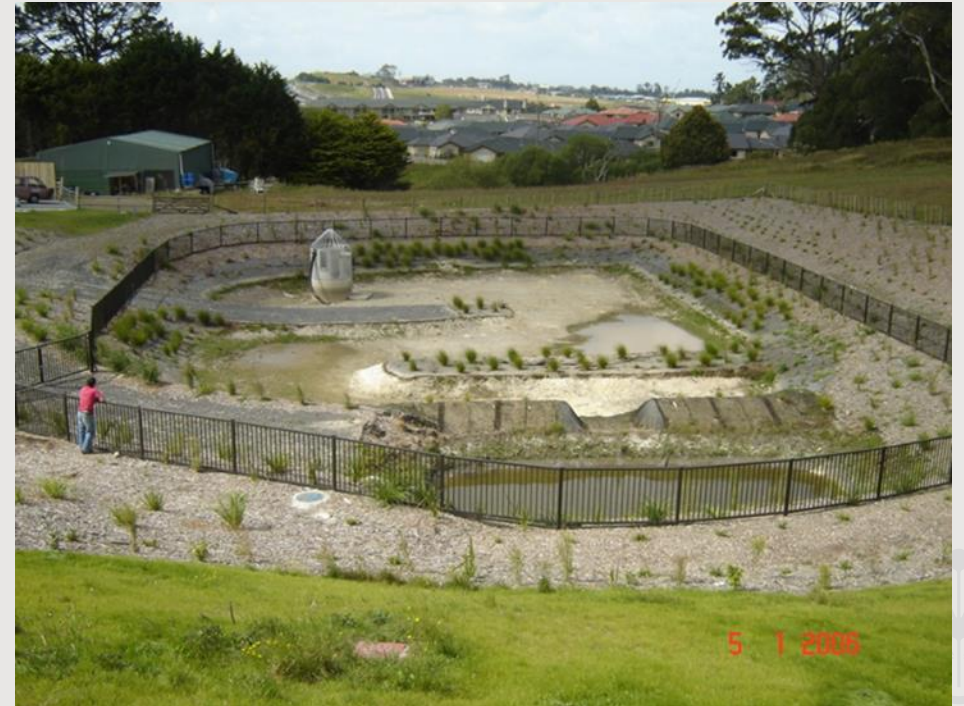
- 33 additional stormwater treatment devices (AC, NZTA)
- Ranging from debris screens, gross pollutant traps (GPTs) to cartridge devices
- Regular inspection & maintenance
